DEPARTMENT OF TRANSPORTATION

Contract #: 04-0120F4Cty: SF/ALA Rte: 80 PM: 13.2/13.9File #: 1.28**WELDING INSPECTION REPORT****Resident Engineer:** Casey, William**Address:** 333 Burma Road**City:** Oakland, CA 94607**Report No:** WIR-029897**Date Inspected:** 29-Jul-2013**Project Name:** SAS Superstructure**OSM Arrival Time:** 700**Prime Contractor:** American Bridge/Fluor Enterprises, a JV**OSM Departure Time:** 1730**Contractor:** American Bridge/Fluor Enterprises, a JV**Location:** Job Site**CWI Name:** Jesus Cayabyab, Bernie Docena**CWI Present:** Yes No**Inspected CWI report:** Yes No N/A**Rod Oven in Use:** Yes No N/A**Electrode to specification:** Yes No N/A**Weld Procedures Followed:** Yes No N/A**Qualified Welders:** Yes No N/A**Verified Joint Fit-up:** Yes No N/A**Approved Drawings:** Yes No N/A**Approved WPS:** Yes No N/A**Delayed / Cancelled:** Yes No N/A**Bridge No:** 34-0006**Component:** SAS Tower**Summary of Items Observed:**

RWR201305-009

ESW W-043, Location "V"-Face B

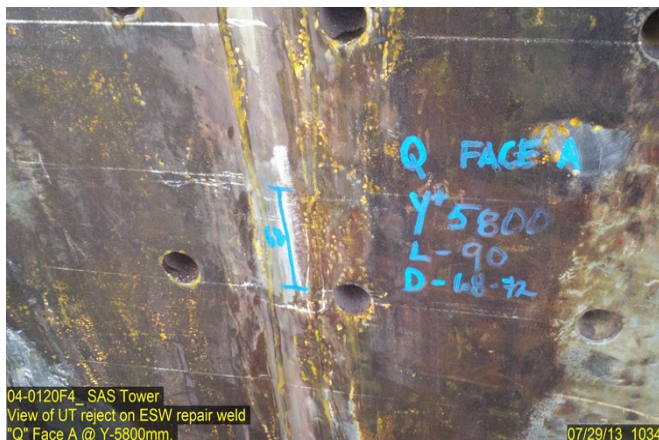
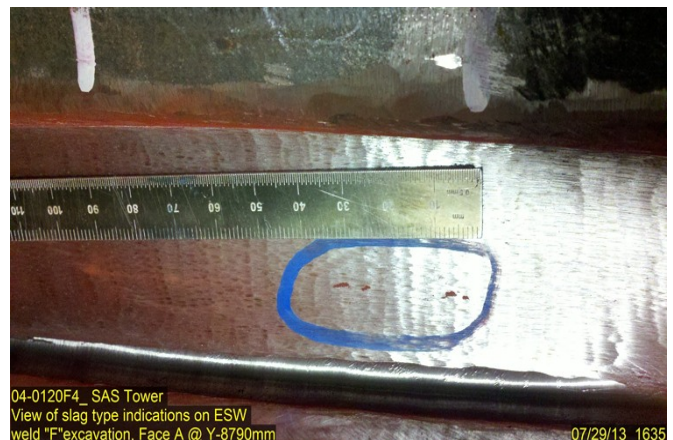
The QA Inspector was later present to observe ABF welder Simon Ma performing exploratory excavation of ESW "F" Face A @ Y-8790mm, 8960mm to verify indications observed during Ultrasonic Testing pulse/echo & pitch/catch. Mr. Ma was performing grinding on the excavation. ABF QC Inspector Jesse Cayayab stated that Mr. Ma will excavate every 3mm deep and allow QC/QA to inspect the excavation. Location of the repair is as follows:

Weld excavated at 16mm- Transverse indications removed @Y-8730, @Y-8760.

Weld excavated at 16mm-Linear indication (slag) @8840, X=-15, L= 4mm

Weld excavated at 19mm- Linear indication (slag) @8840 removed.

Weld excavated at 19mm- Linear indication (slag) @8740, X=-35, L= 3mm

Weld excavated at 20mm- Linear indication (slag) @8820, X=-15, L= 8mm

Weld excavated at 20mm- Linear indication (slag) @8740 remains

Excavation Length Y=8680mm~9090mm (Excavation work in progress to be continued on the next work shift)

After grinding to bright metal the QC Inspector performed MT testing of the excavation to inspect for weld discontinuities at each hold point. See TL-6028 for additional details on items inspected on this date.
